Walter Neser

Are power line incidents underestimated?

Understanding Power-Lines in South Africa

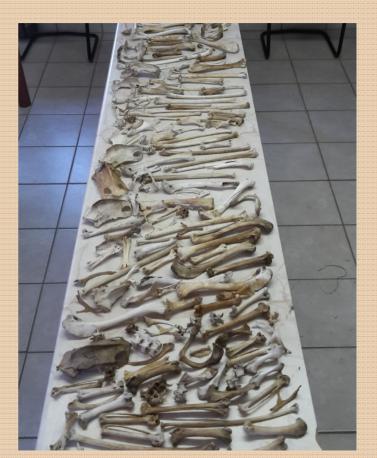
Remains of 15 Cape Vultures collected under one pole, there were 30 more within 2km on this line, the line was erected in 1984 - Neser 2016

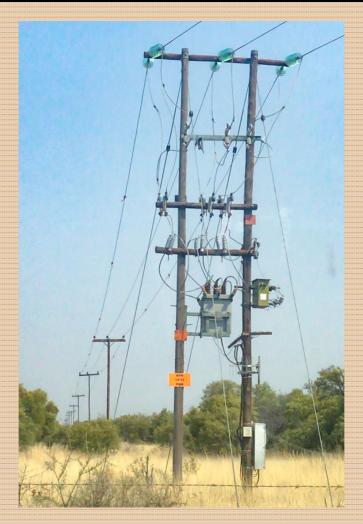
T-Offs, Transformers, Fuses, Breakers & Termination Poles

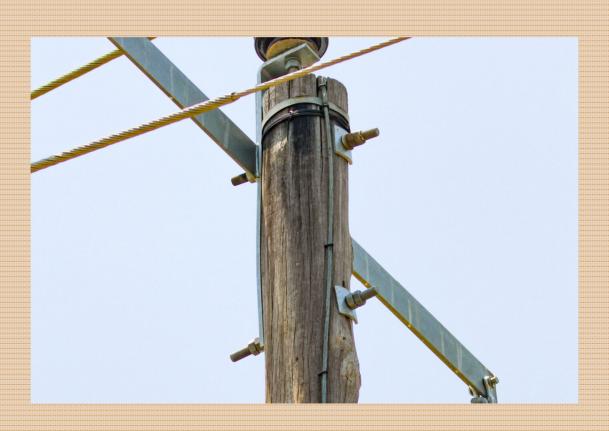
"Live" Earthed Perch (no BILL Gap)

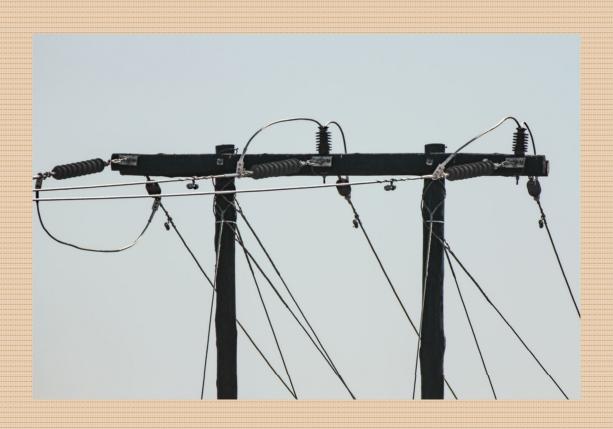
Jumpers above perch / not insulated

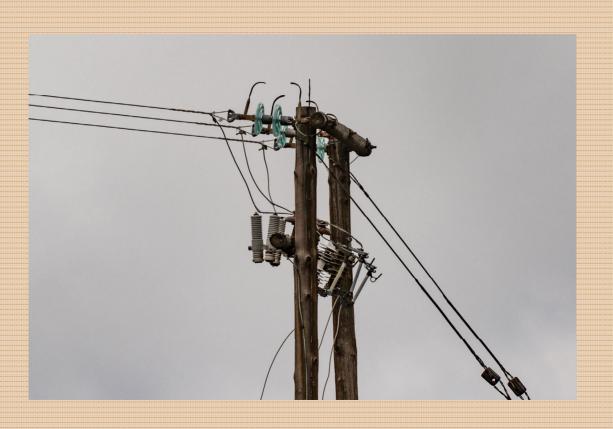
Arc Horns

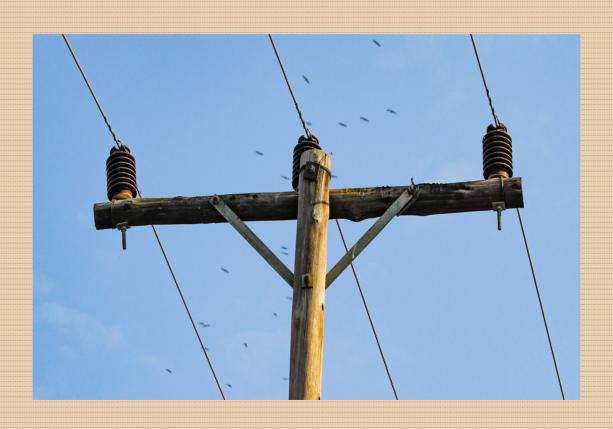
Small Phase spacing

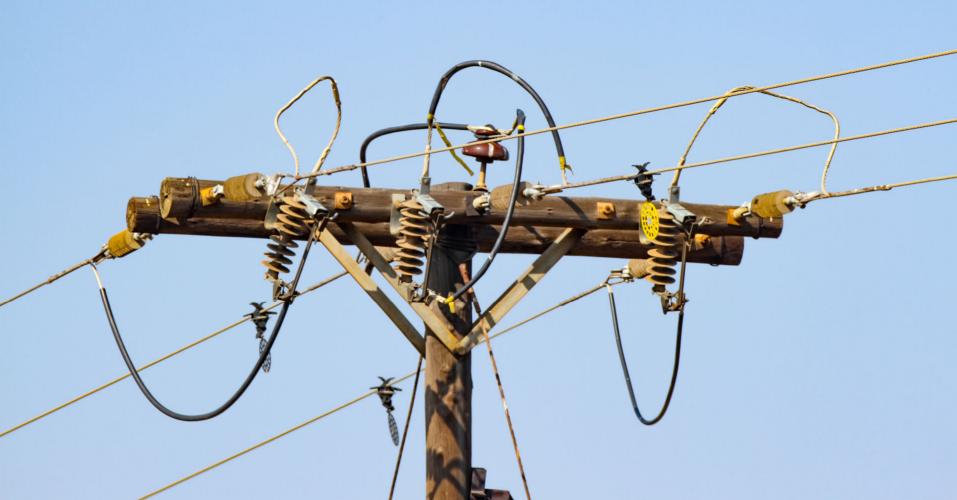
Inadequate

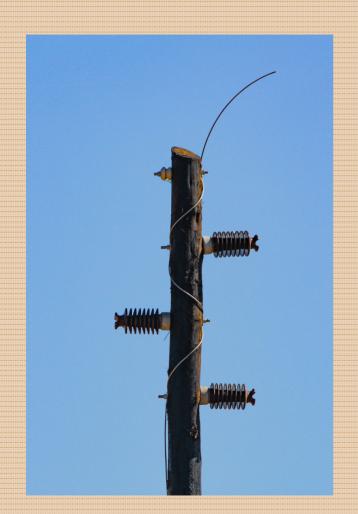
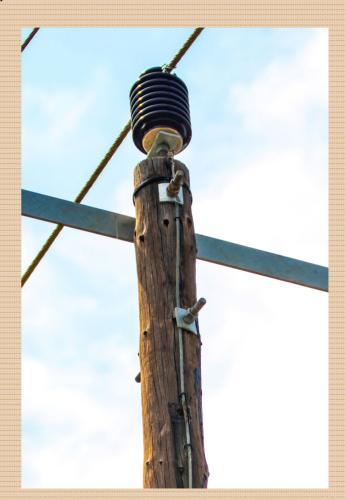
Installation Errors

(old habits die hard)
